All of Lot 6, Block 2, Eccles Subdivision of Block 26, Plat C, Ogden City Survey, Weber County, Utah.

Surveyors Narrative

Project Participants	
Research by:	Tharper
Site Investigation:	Anderson, Stene
Plat Report Draft:	Anderson
Reviewed by:	Tharper
January	2025
24057

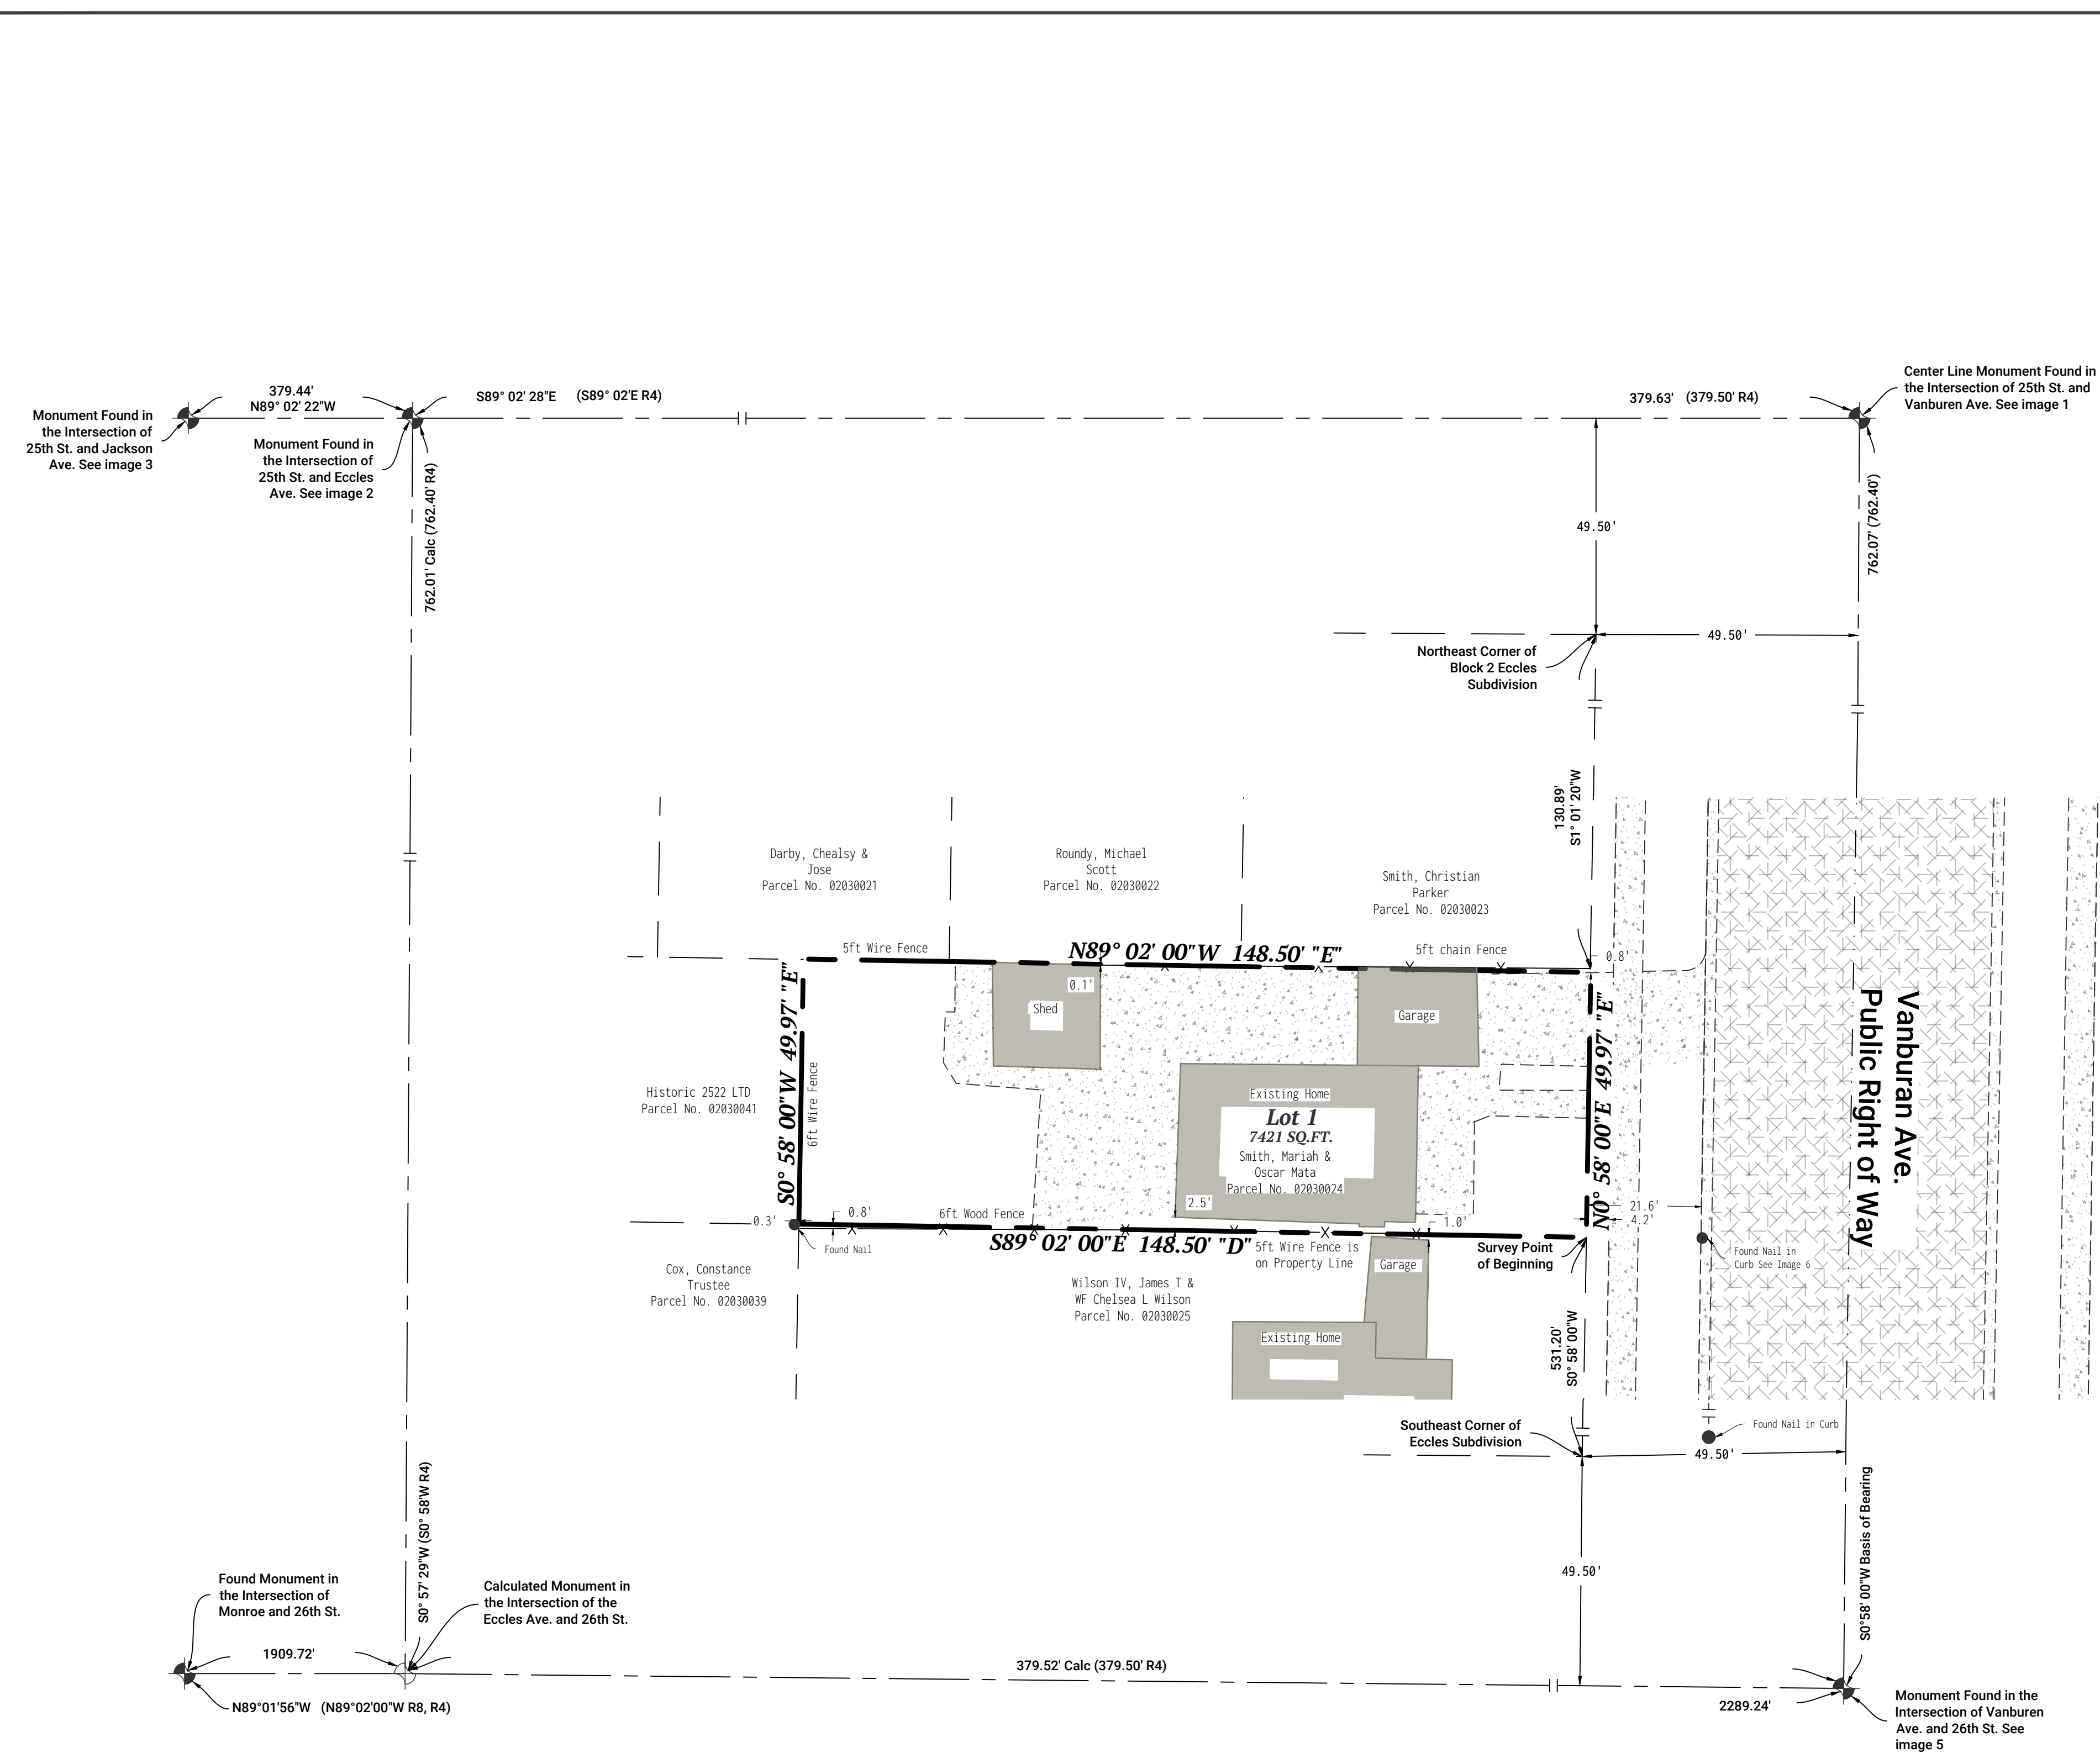
- A. This Survey was requested by Oscar Mata to retrace his property boundaries and assess facts along the South property Line.
- B. Basis of Bearing for this Survey is South 0°58'00" West measured two Ogden City Monuments within Vanburen Avenue at the intersections of 25th street and 26th Street.

- C. This Survey did not find any Evidence from the original Survey Besides the Center Line Monuments. With this the Surveyor prorated the length of each lot to make up with the deficiency in verifying this approach no evidence was found to disprove it.

- D. During the site investigation two nails were found in the curb and one nail in the rear of the parcel 02030024 in searching around said parcel no rebar or caps were found to identify the Surveyor. With no record of survey the surveyor does not know how they were established. In looking at the nail at the Southeast corner of this Survey property it seems to have been established at the record position without accounting for deficiencies in the Lot. But when looking at the nail at the Southwest corner of said Survey property and drawing a line between the monuments the line matches with the old fence line. With said nails not being where the Surveyor who established it not accounting for the error in the Lot. Meaning did this unknown Surveyor establish the Boundary by acquiescence? The facts suggest that could be the case. The relationship of the boundary by establishment from prorating places the boundary just South of the fence by under a tenth, form this survey's measurement points. When taking into account the nails which bearing matches the old fence and in seeing the age of the fence this survey believes the Boundary to be along the fence Line.

- E. Following record as described in Section C.
- F. Property corners were monumented as shown here on and serve as the research and analysis completed in this survey should any data that is not mentioned be found that is contrary to this survey it should be presented for consideration.
